# **Stainless Steel Clad Rebar in Bridge Decks**

**Study SD2000-04  
Final Report**

**Department of Materials and Metallurgical Engineering  
South Dakota School of Mines & Technology  
Rapid City, SD 57701**

**November 2001**

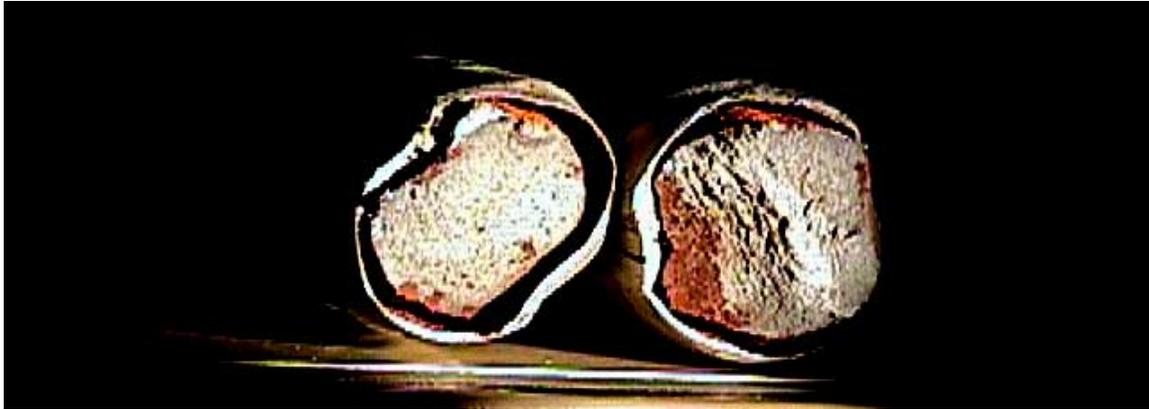
**Figure 1: Photograph of a tensile test failed SSC rebar**

For the mechanical property testing, Figure 1 shows a photograph of a tested bar. This photo indicates that the core and cladding behaved separately. The core failed prior to the cladding. The mechanical properties examined were elongation, tensile strength and yield strength. The SSC rebar had greater elongation and tensile strength than the specifications, but the yield strength had only a 67% probability of being greater than the specification if 0.76" was used as the bar diameter. The bar diameter was quite variable and could be anywhere from 0.70" to 0.78" for a bar of size #6, which should have a diameter of 0.75". For the Ontario Ministry of Transportation (MOT) #6 bar, the cladding thickness was never measured to be less than the specifications for the material.

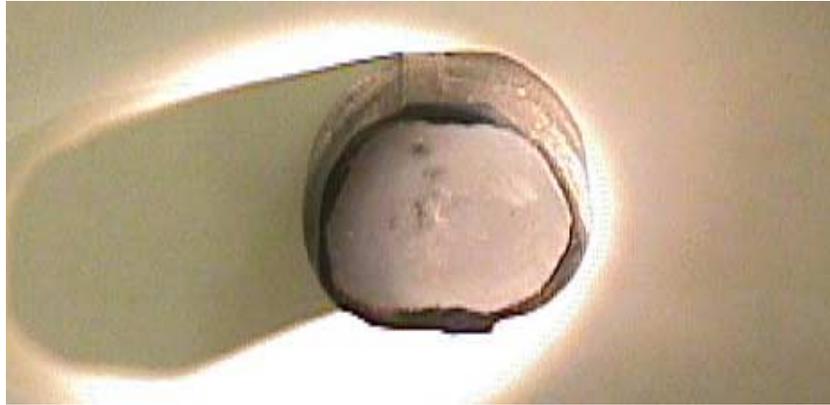
**Figure 7: Cut Surface a #6 SSC Bar**

Samples of both #6 and #10 stainless steel clad material were examined to determine their nominal size, cladding thickness, core homogeneity and thickness of gap between core and cladding. Figure 7 shows one of the #6 samples used.

Large differences in cladding thickness are evident from Figure 7. In addition, some pull away of the cladding from the core is also evident. The cladding thickness was measured using image analysis. For one sample, 27 measurements were taken; for the second sample, 15 measurements were obtained. The average cladding thickness for sample 1 was 1152.5  $\mu\text{m}$  (about 45.5 mil) with a coefficient of variation of 42%. The smallest thickness measured was 261  $\mu\text{m}$ , about half the minimum specification. For sample 2, the average cladding thickness was 1349  $\mu\text{m}$  (about 53 mil) with a coefficient of variation of 55.6%. The smallest cladding thickness measured on this sample was 550  $\mu\text{m}$ .

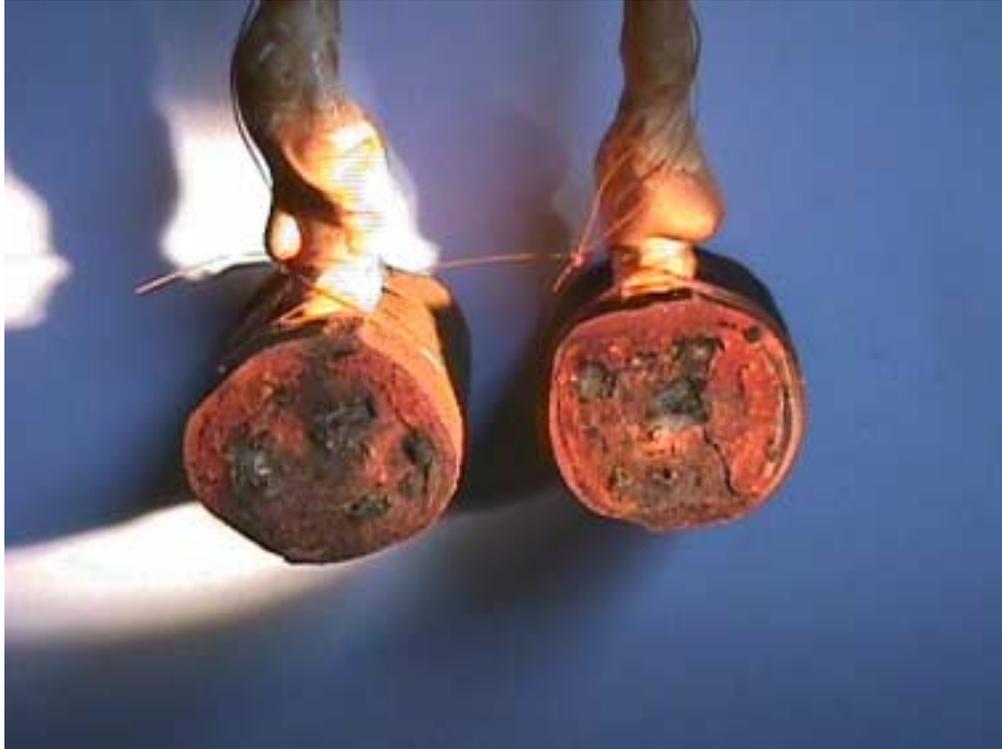
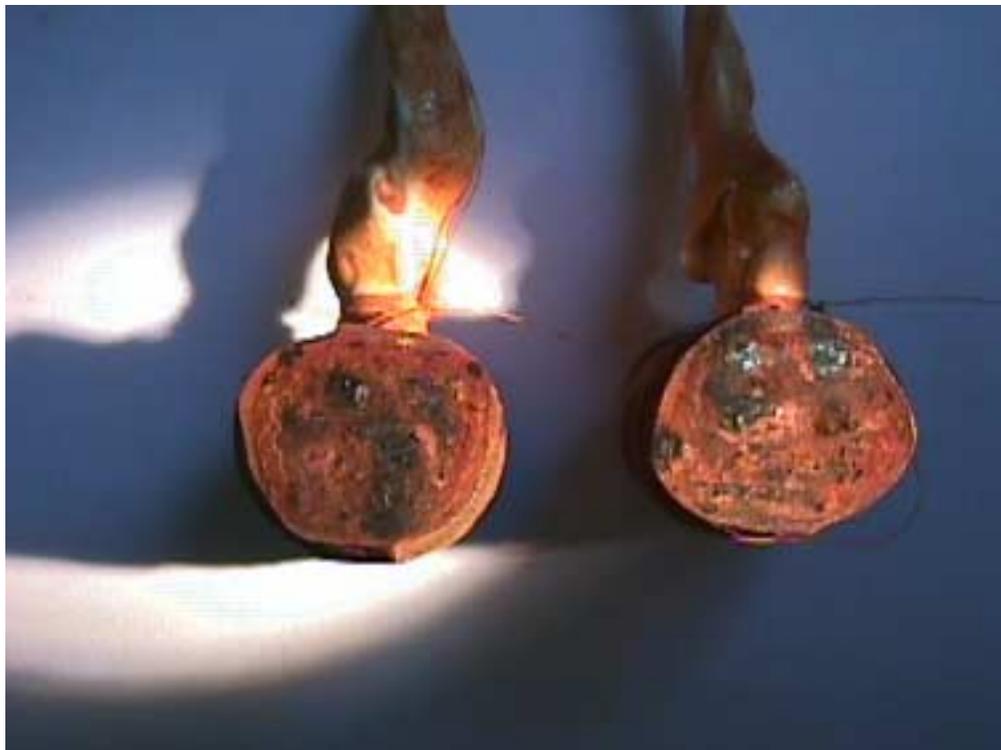
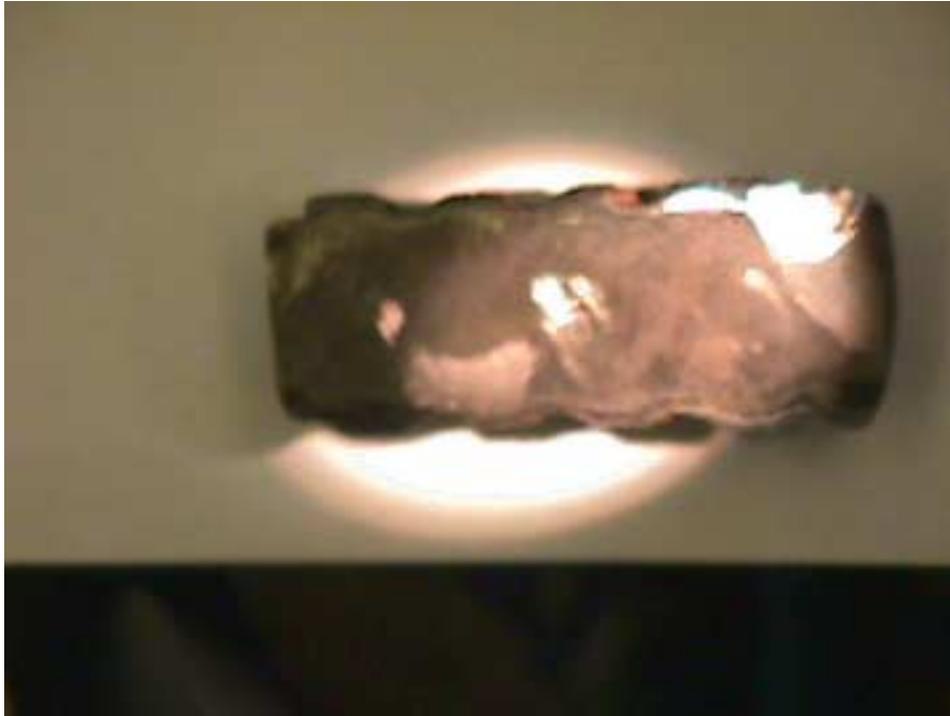
**Figure 17: Uncoated SSC Rebar After 8 Days at pH6, 60°C**

**Figure 18: Uncoated SSC Rebar After 8 Days at pH6, 60°C, Other Side Of Sample from Figure 17**

**Figure 19: Cross Section of Stainless Steel Coated SSC Rebar Tested 8 Days at pH6, 60°C**

Figure 17 through Figure 19 show photographs of the SSC rebar after the initial corrosion testing. The primary corrosion by-product was iron oxide, as expected.
